Appendix B: Agency Correspondence

To: CJV
 From: LINK427 Design Team
 Title: Pond-2 Outlet Relocation

Date: Thursday, June 27, 2019
 No. MEMO-250 R1

**Re: Pond-2 Outlet and Drainage Feature Technical Memo
Highway 427 Extension Project
GEO Morphix Project No. PN17022**

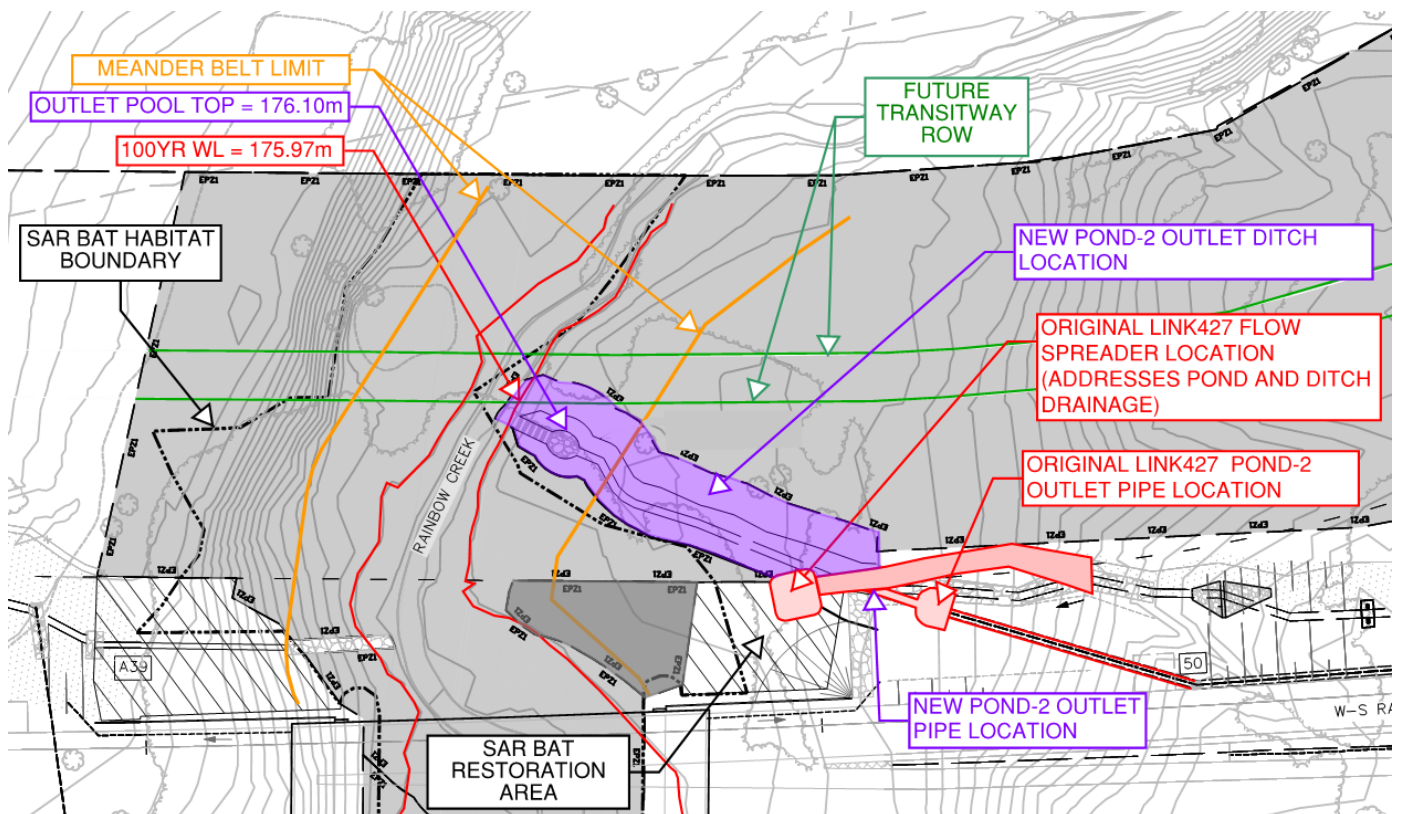
Figure 1 - Pond-2 Outlet Original and Proposed Location

In the design presented in DCR#4 (original LINK427 design), the outlet pipe from Pond-2 discharged to a plunge pool as shown in blue in **Figure 1**. From there, runoff was conveyed by a swale to a flow spreader shown in red in **Figure 1**. From the flow spreader, runoff was to sheet flow over vegetated surfaces, ultimately discharging to the creek. Subsequently, the 3D surface modelling for the outlet area was refined and it revealed that positive drainage could not be provided with the original outlet configuration. In order to provide positive drainage, the flow spreader would have to be relocated at a lower elevation and be moved within the EPZ2 (shown in dark grey in **Figure 1**) and within Species at Risk (SAR) bat habitat (SAR bat habitat boundary depicted by dashed line in **Figure 1**), which was not a feasible option, as the flow spreader would have been a permanent disturbance in an area (EPZ2) where only temporary disturbance is allowed. After multiple design iterations and multidisciplinary review, it was concluded that the optimal location would avoid the SAR bat habitat, the Future transitway right of way and the EPZ2 area. This optimal location is highlighted in purple in **Figure 1**.

As shown in **Figure 1**, the outlet pipe from Pond-2 will still discharge near the original location. Runoff will then be conveyed via a bio-swale, which directs flows to a pool at the base of the slope for increased flow retention and infiltration. Both the bio-swale and pool are lined with a mix of soil and granular materials (e.g., river stone) and covered with a biodegradable erosion control blanket (see attached stormwater management details, DWG 2213). Additionally, a high density of live staking is proposed throughout to enhance the stability of the feature through root generation. During periods of high flow, runoff will be guided downstream of the pool through a series of wattles, which will act to further regulate flows near the creek. The wattles will consist of bundles of live woody debris bundles, which should be sourced on-site, where possible. Additionally, based on input from the fluvial geomorphologists, the placement of the drainage feature has been intentionally situated away from any immediate channel meanders. A level of lateral migration is expected over the long term beyond 100 years but it is not considered significant. Bio-swale details have been included in the attachment (Stormwater management details, DWG 2213). It is worth mentioning that the relocation of Pond-2 outlet was not caused by nor will impact Pond-2 hydrology or hydraulics. Further details relating to hydraulic of the bioswale and outlet design as well as implementation and restoration recommendations are described in the Pond-2 Outlet and Drainage Feature Technical Memo by Geo Morphix attached.

The vegetation community impacted by the new location of the drainage feature is not SAR Bat Habitat as defined by the boundary delineated in the SAR Bat Permit (Permit # AU-C-011-16) (and shown on **Figure 1**) or by the vegetation community types present in this area. The impacted habitat is a mosaic of Mineral Cultural Thicket (CUT1) and Old Field Meadow (CUM1-1). These vegetation community types do not qualify as potential SAR Bat Habitat according to the latest MNRF technical guidance documents.

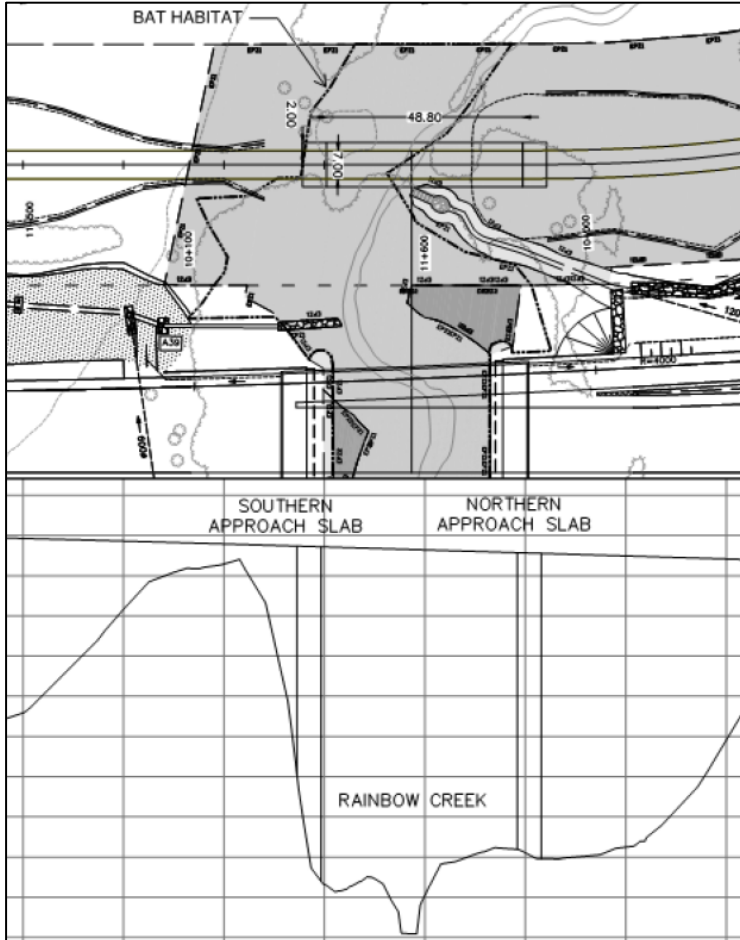
Figure 2 - Future Transitway Preliminary Plan and Profile

An analysis was completed to demonstrate that the future Transitway construction will not be impacted by the proposed Pond-2 outlet ditch into Rainbow Creek. **Figure 2** shows a preliminary plan & profile of a potential future Transitway bridge over Rainbow Creek with a similar profile and span configuration as the Highway 427 bridges. The preliminary grading lines shown indicate that there is adequate room for conventional construction of the bridge approach and grading treatments surrounding the future abutments, with no additional work to be performed by the CA. The outlet can be relocated in the future if deemed necessary.

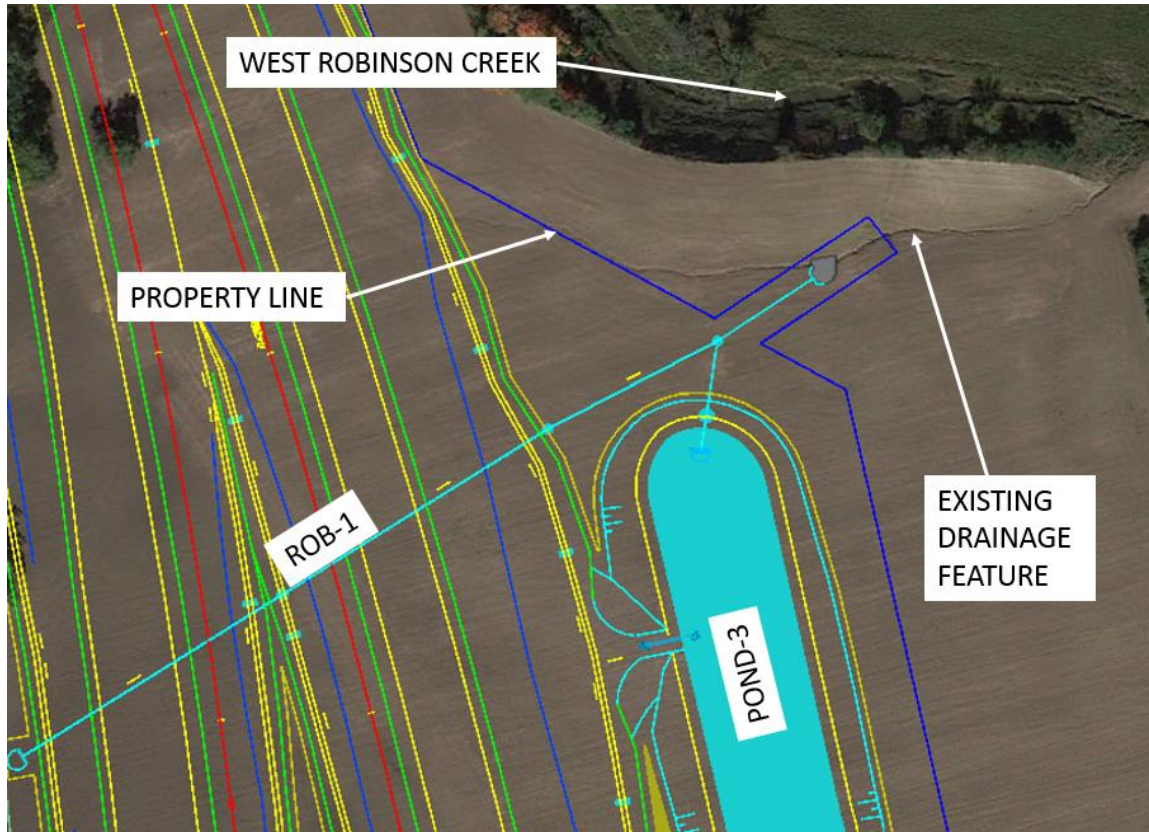
Figure 1 – Site Details

This memorandum has been prepared to present the permanent and temporary works required to avoid erosion impacts on the existing drainage feature that will receive drainage from ROB-1 and Pond-3 as shown in Figure 1.

Prior to the commencement of construction, the existing drainage area that outlets to the “existing drainage feature” north of Pond 3 shown in Figure 1 above was much smaller than currently designed. The MTO EA design (RCD) established an external catchment area for ROB-1 that included lands which previously drained to a feature south of Pond 3. As a result of the increased catchment area and flow from Pond 3 entering the existing drainage feature, it has been determined that without design improvements, significant erosion can be expected.
